### Hitachi 5500 Face Shovel Hydraulics System Bypass : Thiess - Liddell Coal, Hunter Valley

FTA was approached to install a bypass filtration system on the hydraulics of a 5500 Hitachi Face Shovel being commissioned for Thiess at Liddell Coal in the Hunter Valley.

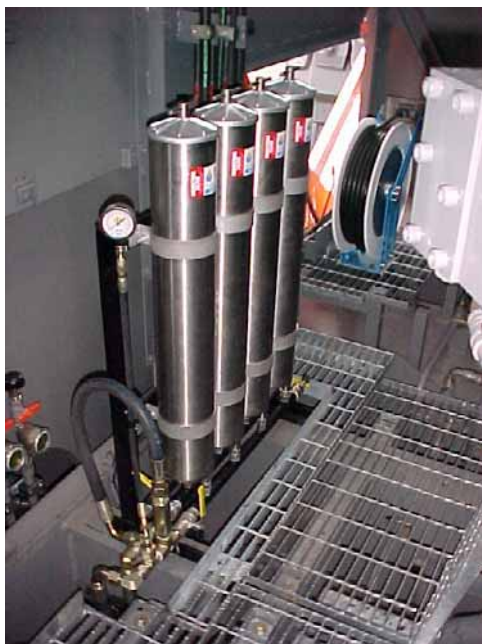
The shovel has a 6,500 litre hydraulic system so it was decided to install a JQ440 filtration system on board using a spare pump that was available in the hydraulic circuit.

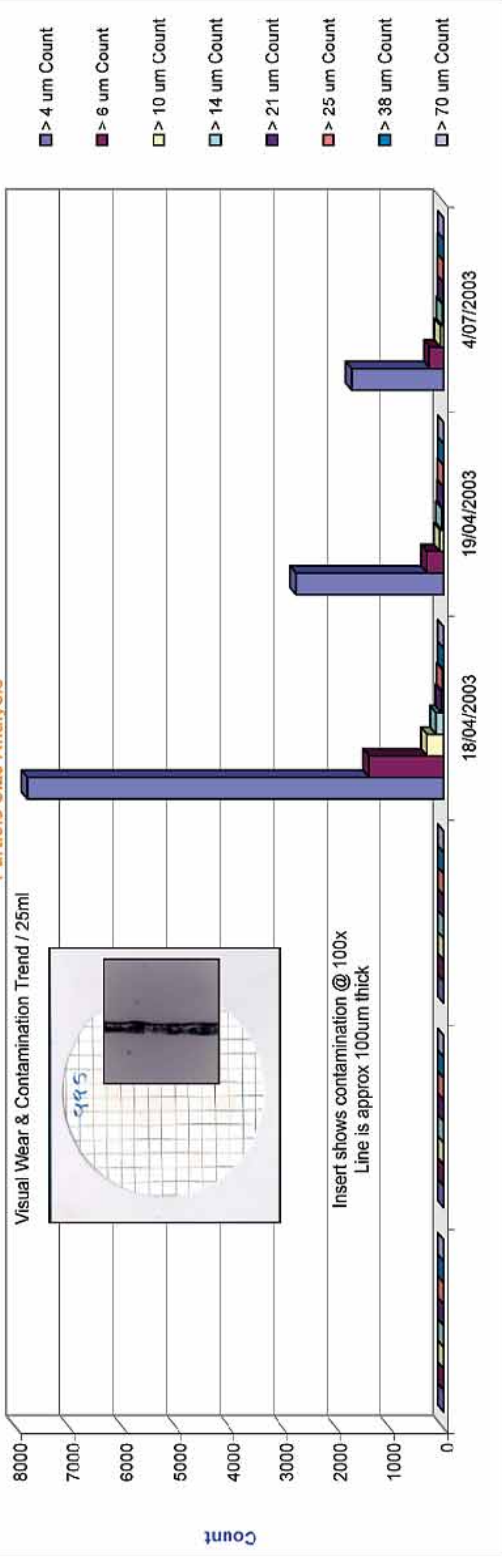
Insert shows contamination @ 100x  
 Line is approx 100um thick

Results within acceptable limits.  
 Continue with regular maintenance and monitoring. NOTE: Element was 500hrs old at time of sampling.

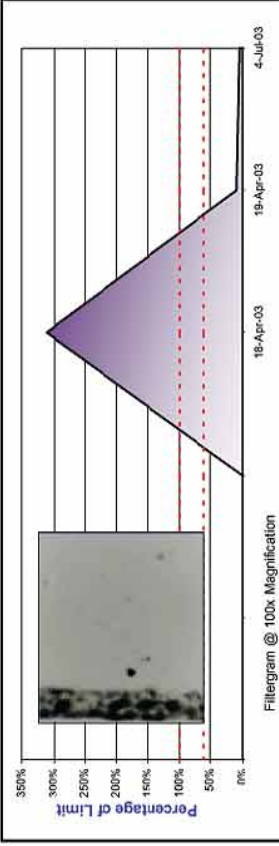
### PO - Ferrrous Wear Debris (Fe ma \ ltr)

particle count in 1ml	7807	2769	1733
ISO-4406 6um \ 1.4um	18/13	18/14	15/12
PQ90 Fe - mg \ ltr	-/-	62	2

Results within acceptable limits. Continue with regular maintenance and monitoring. NOTE: Element was 500hrs old at time of sampling.

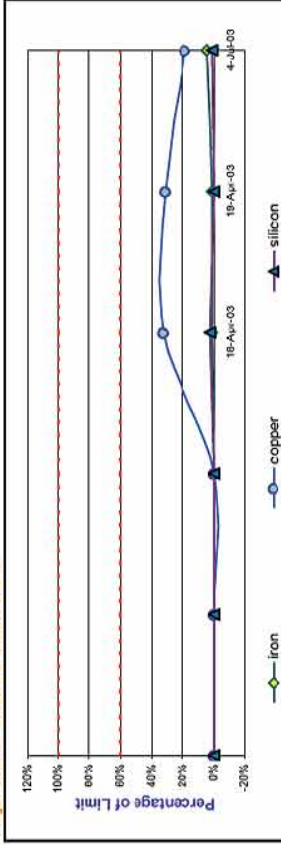
### Major Small Particle Element Trends

Limit	18-Apr-03	19-Apr-03	4-Jul-03
lead ppm	0	0	0
iron ppm	1	1	3
aluminium ppm	0	0	0
copper ppm	19	19	11
chromium ppm	0	0	0
tin ppm	0	0	1
nickel ppm	0	0	0
silver ppm	0	0	0
titanium ppm	0	0	0

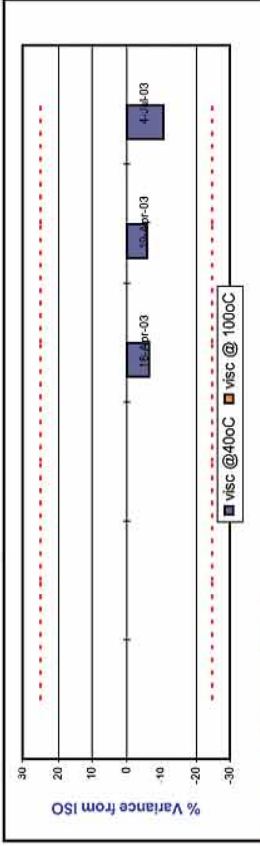
### Viscosity Condition From New Oil Specification

TBN	0	0	0
TAN	0.00	0.00	0.00
fuel dilution %	0	0	0
water %	0	0	0
viscosity index	141	135	128
visc @ 100oC - Cst	7.48	7.37	6.93
visc @ 40oC - Cst	43	43	41
